Cast Stone panels were cast to replicate the highly intricate designs contained in the original panels.

8'-3" high x 44'-0" long

In 2023, Sun Precast and C&D Waterproofing were contracted to restore the 8'-3" high x 44'-0" long Cast Stone Mural Panels on the north elevation of the PA Farm Show Complex building. The north panels were severely deteriorated, but there were identical panels in good condition on the south elevation of the building.

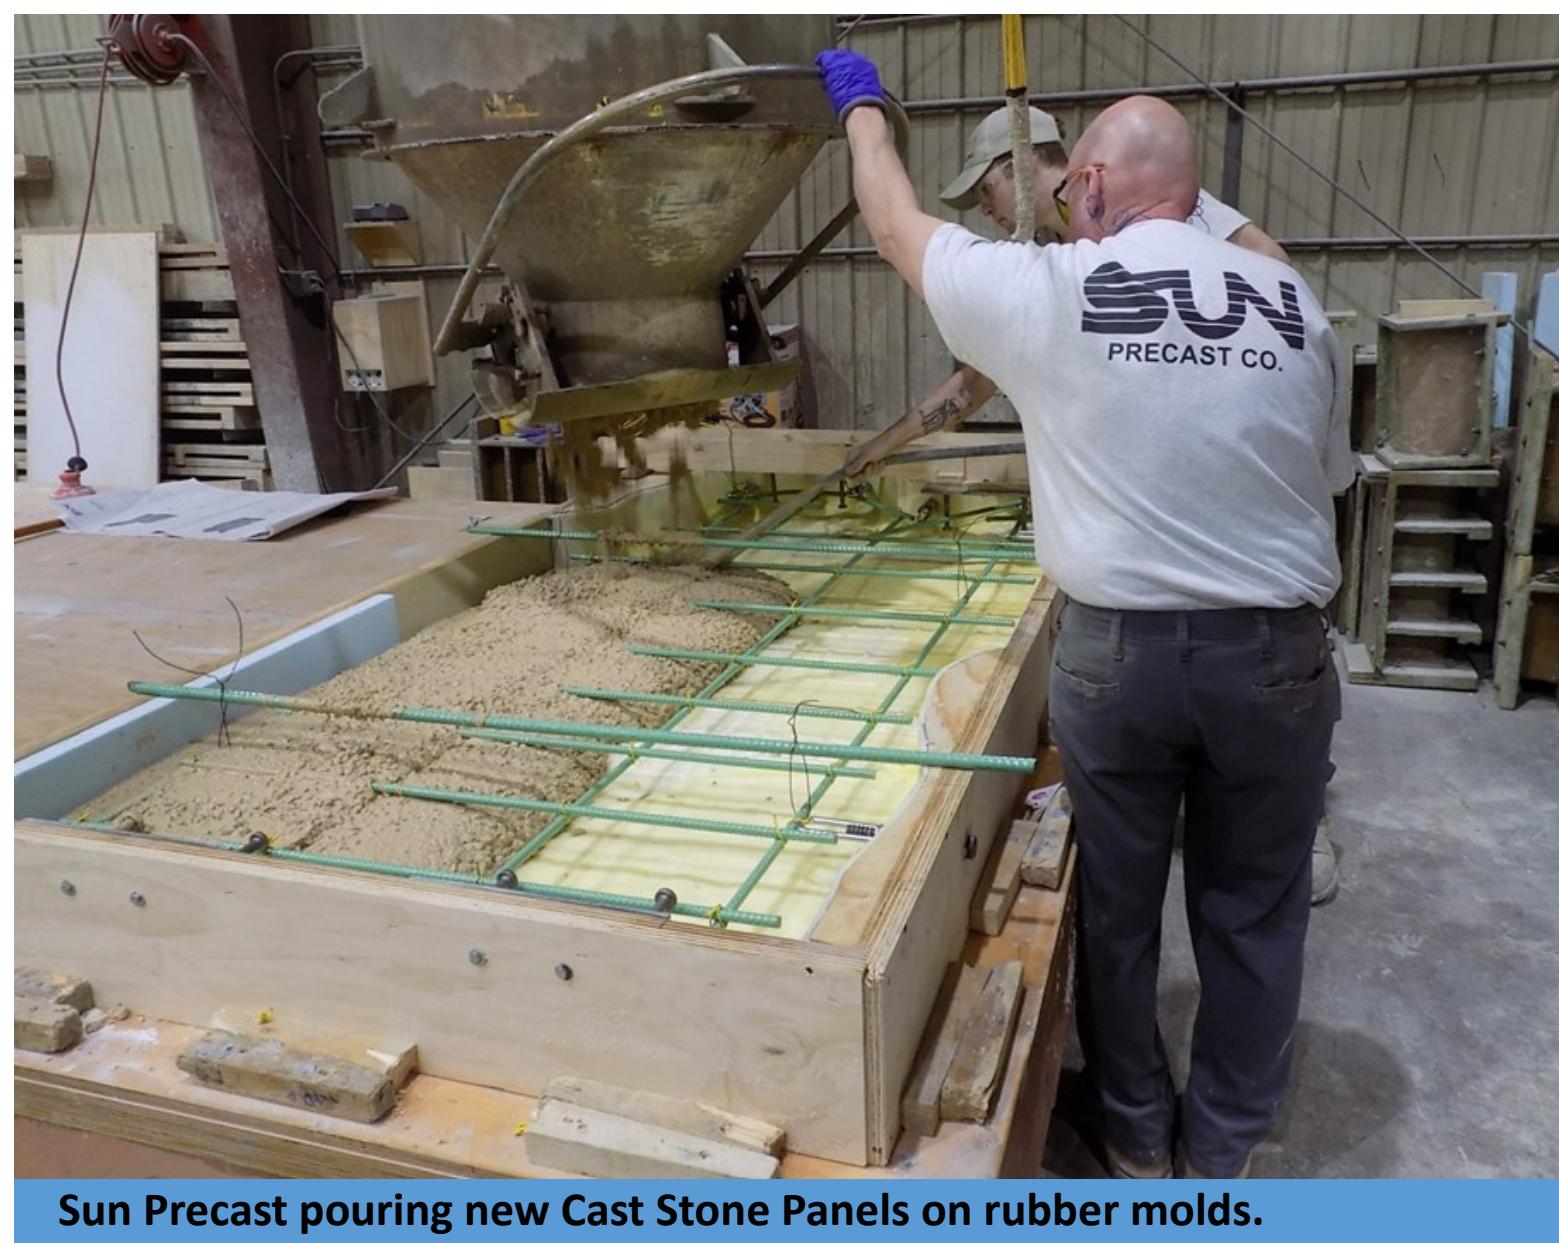
Sun Precast pouring new Cast Stone Panels on rubber molds.

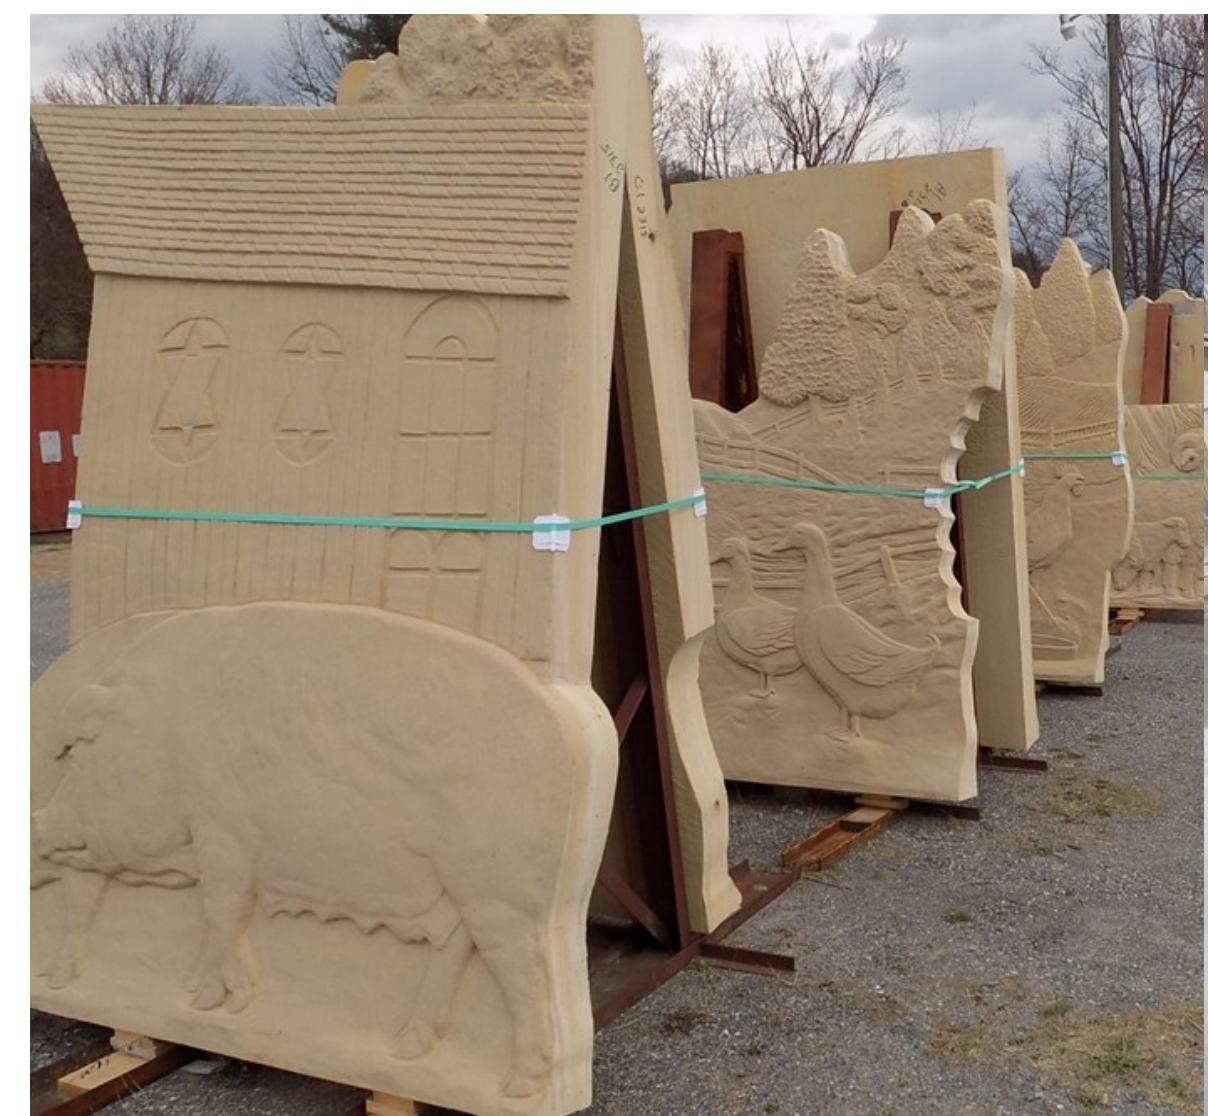
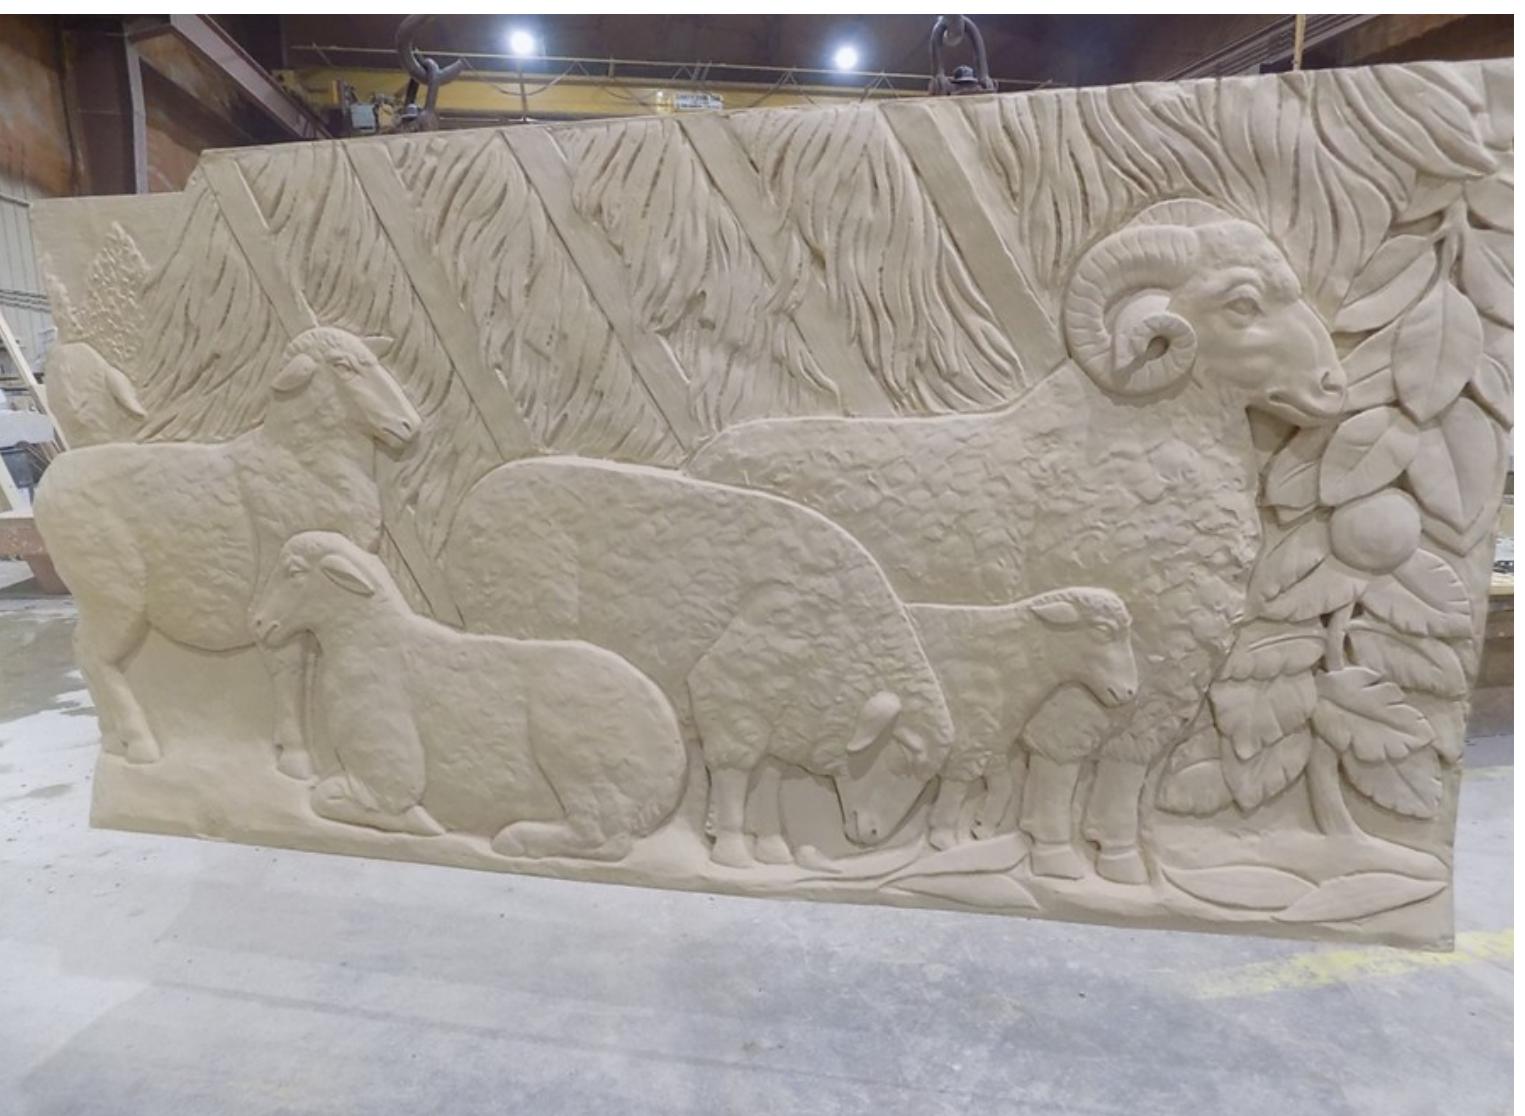
New Cast Stone Panels

Once rubber molds were created, new Cast Stone panels were cast to replicate the highly intricate designs contained in the original panels. The molding process also required fabricating custom fit mold sides that correspond to the irregular panel shapes. The end product – a perfectly restored panel wall. The detail is astounding! Check out the distinction of the turkey's feathers, the texture of the sheep's wool, or the detail of faces and buildings.
